Commercial Venting CASE STUDY

Impossible Made Possible With Integral Chased Grease Duct

Factory-Built Grease Duct - 5 Years Later...

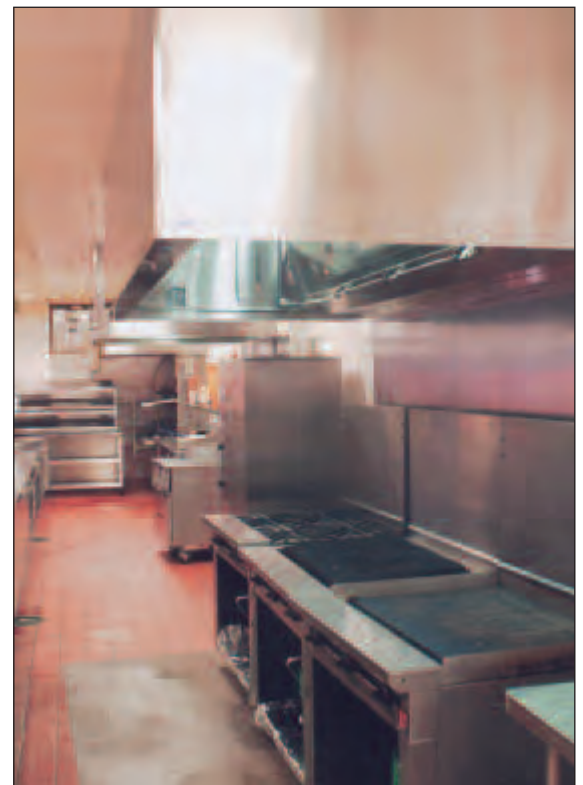
Fifteen new hoods were installed.

New kitchen area plans departmentalized the food preparation and cooking stations on both the main and lower levels. In all, 15 new hoods were installed. The new system handles over 56,000 cfm of kitchen exhaust air. Each hood is equipped with its own blower.

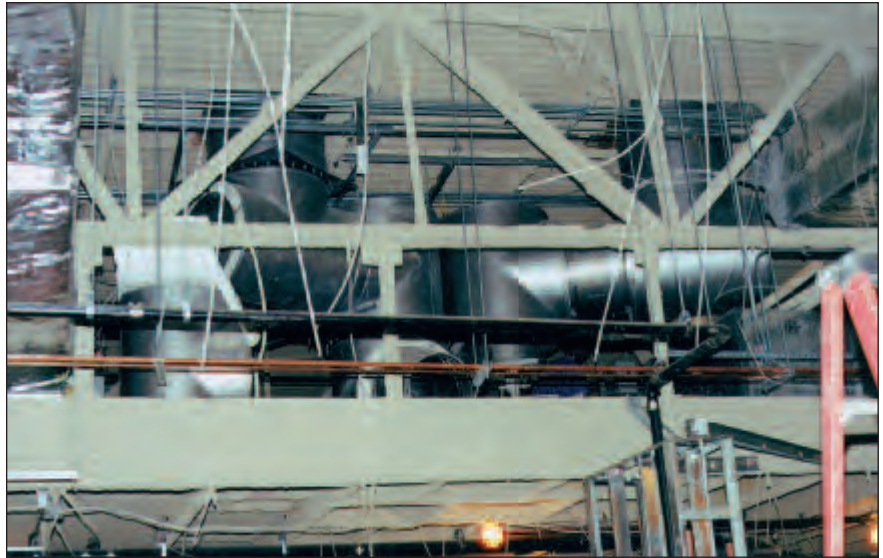
Space was tight, especially in the mechanical mezzanine above the original kitchen area.

through various levels of the structure would have to be constructed. We felt that required duct clearances to combustibles could not be reasonably maintained. In addition, concrete ceiling beams and floors were low. There were two ceilings above the kitchen. Ducting had to be worked around concrete pillars and other piping.”

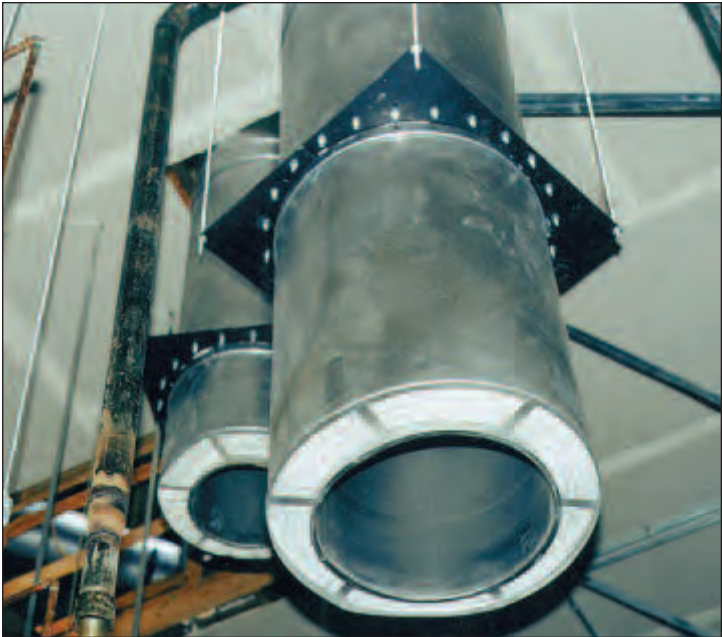
Requiring no chase and no clearance to combustibles, Metal-Fab’s Series 4G Grease Duct allowed installation in otherwise impossible areas.

Working with Hunton Specialty Products, the Metal-Fab representative agency in Houston, the engineers specified Metal-Fab’s Series 4G Grease Duct. The grease duct is a round, insulated grease duct with an integral chase that allows a zero clearance to combustibles and required no welding. Series 4G is a proven alternative to welded duct. No other grease ducting system has undergone the extensive independent testing conducted on Metal-Fab Series 4G. Portions of UL 103, UL 1978, ASTM E814, and ASTM E119 were combined to determine structural integrity, clearances to combustibles, rated partition penetrations and overall safety. The test data was submitted to BOCA, ICBO, and SBCCI, and all three code agencies have recognized Metal-Fab Series 4G as an alternative grease ducting system; the only factory-built integral chase/zero clearance system to be recognized by all three agencies.

By facilitating zero clearance to combustibles and requiring no welding, Series 4G eliminated the cost of welding and insulating duct, fabricating a chase, and provided contractors extra room to work ducting into tight spaces. Available in sizes from 6” to 38” in diameter, Sbisa Dining Hall required ducting up to 26” in diameter and was installed right up to combustibles with no problem. The Series 4G Grease Duct also met Jaster’s requirement of a round, easy to clean duct system.

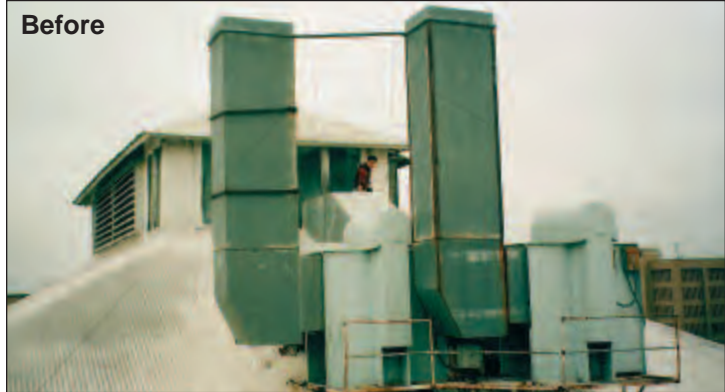
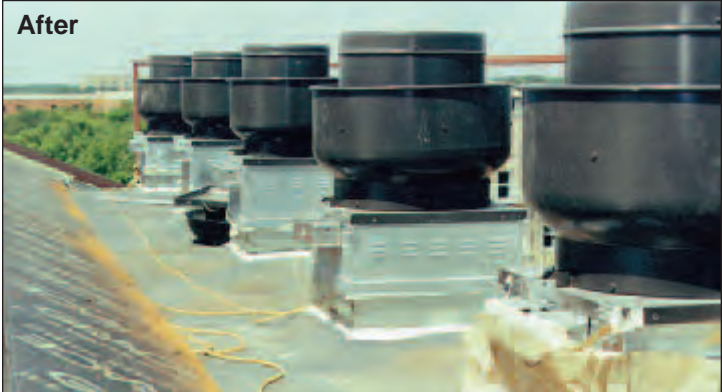
Three large exhaust fans were replaced with multiple smaller fans to serve several smaller cooking and serving stations. This allowed more efficient use, but required multiple duct installations and penetration through already congested areas.

The previous kitchen layout incorporated three large exhaust fans, two fans exhausted four extremely large hoods in the kitchen. The third fan served several smaller hoods in the serving area. These powerful fans were set at the top of the building and, during operation, it was necessary to open the building windows to provide make-up air.

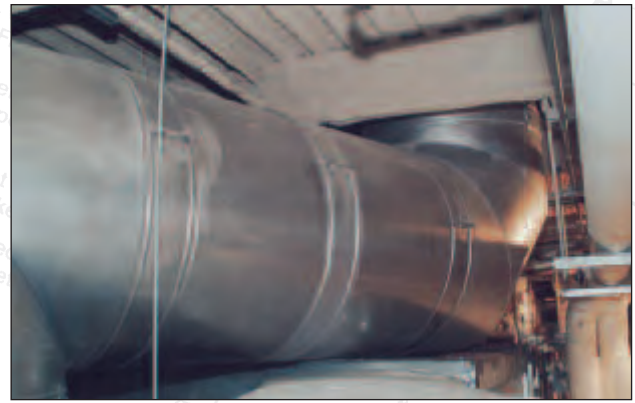
Metal-Fab Series 4G Grease Duct is leak-free.

"It takes less than a day now, where it used to take about four days to clean the old black iron duct in Sbisa Dining Hall. Accessibility is easy and all we have to do is chemical spray and rinse, and there are no leaks in the duct. I also think the regular cleaning schedule makes cleaning easier," Kurt McCoslin, Triple B president stated.

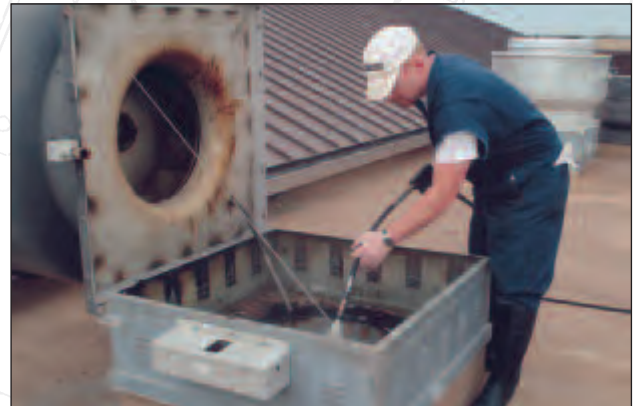
Spraying from roof down, no leaks below.
